Design Hydraulic Study

Hackstaff Road over Long Valley Creek, Bridge 7C-081

Lassen County

May 5, 2015

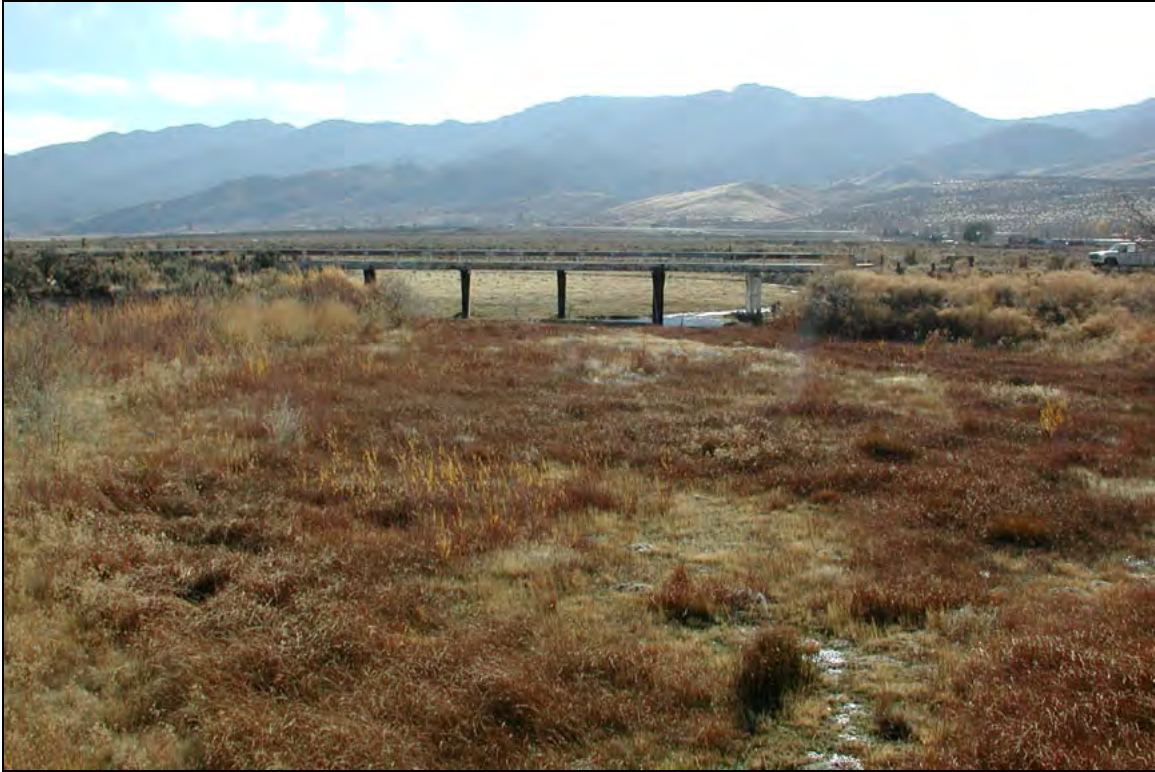
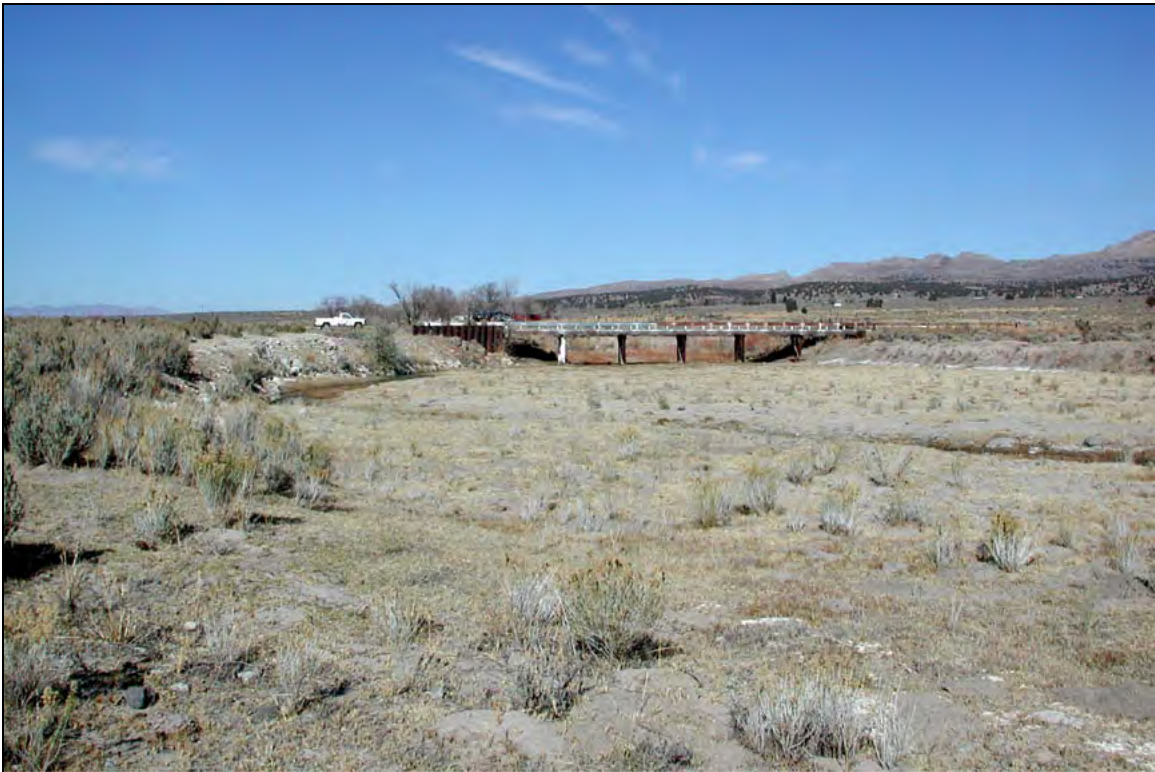
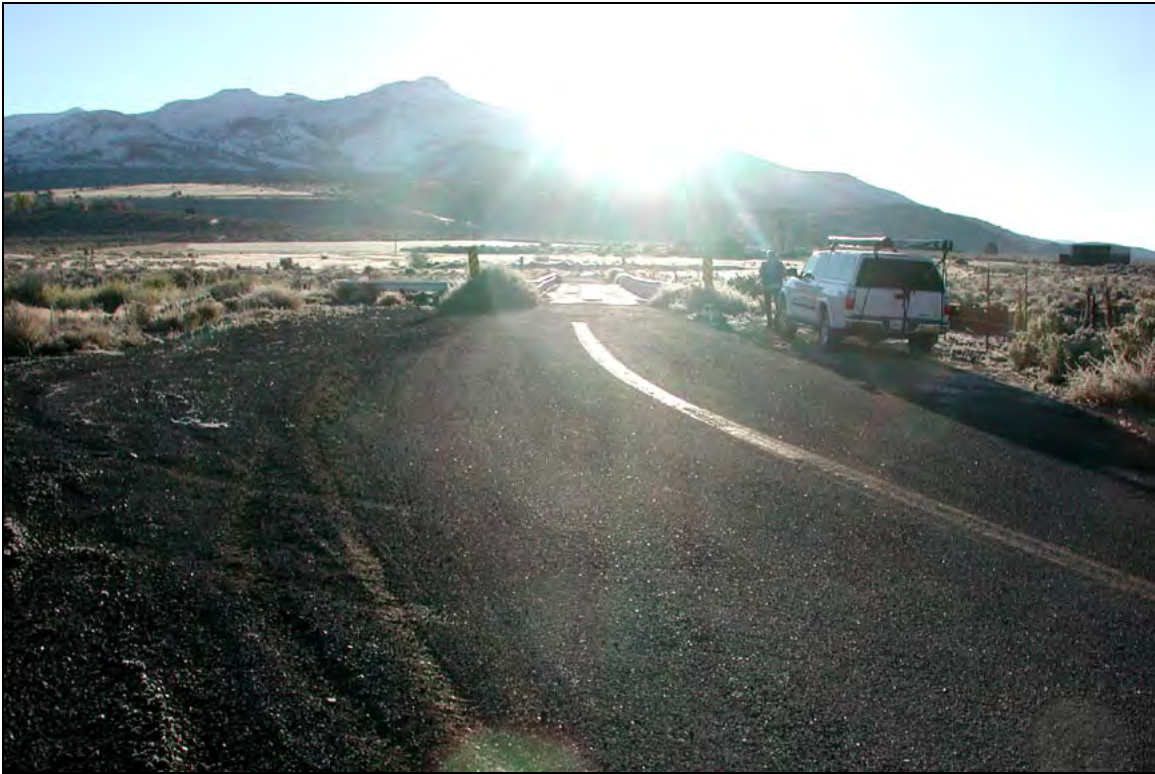
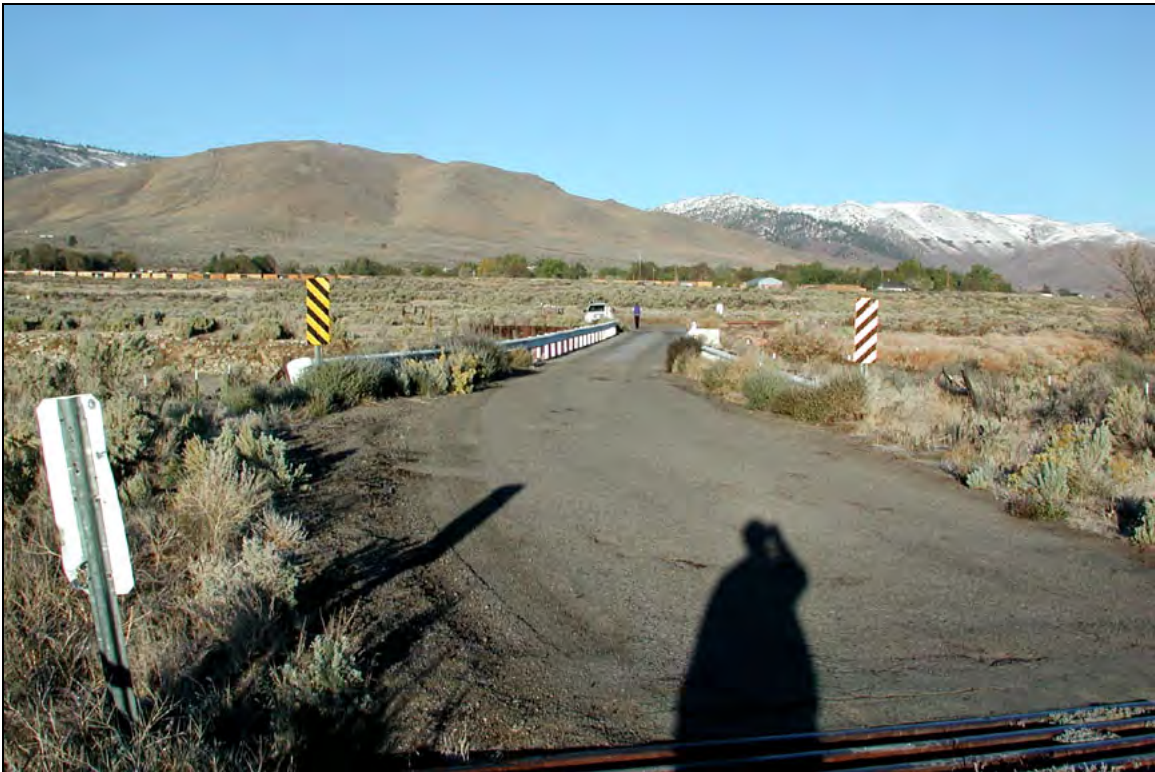
Photos 1-4, pages 11, 12

Photo 1: Looking downstream (north) at Bridge 7C-81,  
Hackstaff Road over Long Valley Creek

Photo 2: Looking upstream (south) at Bridge 7C-81,  
Hackstaff Road over Long Valley Creek

Photo 3: Looking east at Bridge 7C-81,  
Hackstaff Road over Long Valley Creek

Photo 4: Looking west at Bridge 7C-81,  
Hackstaff Road over Long Valley Creek

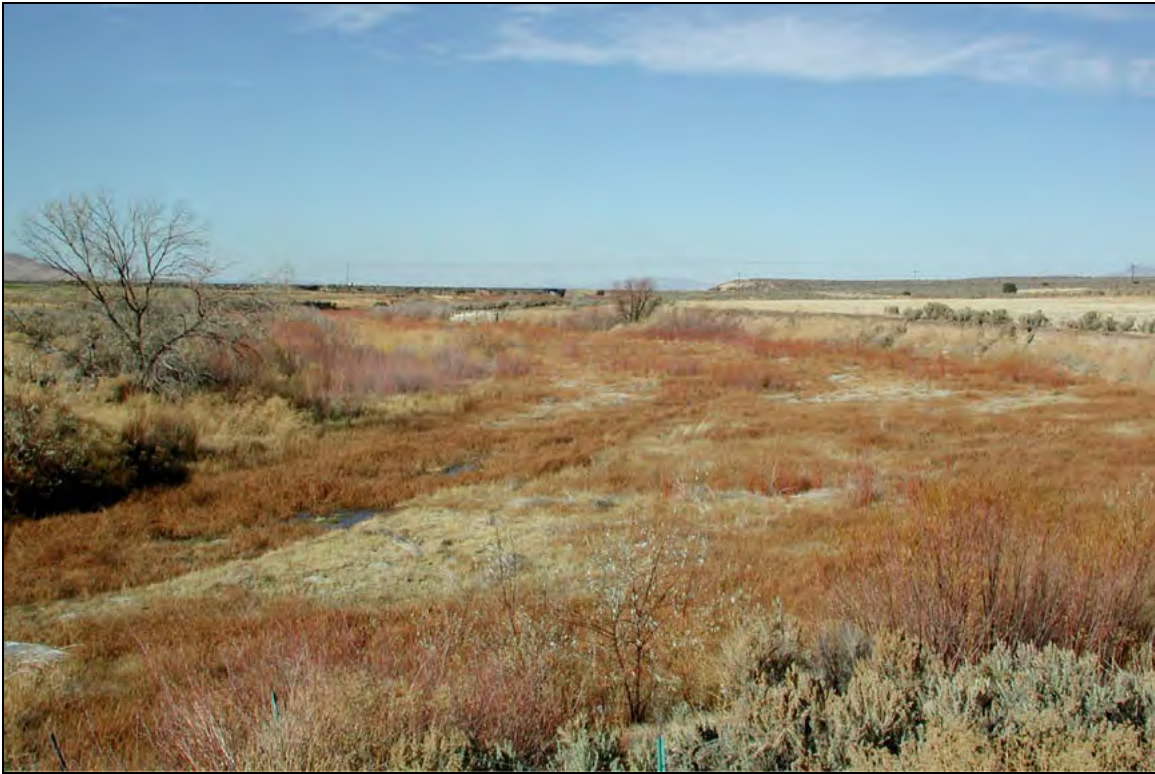
Photo 5: Looking downstream (north) at Long Valley Creek  
from Bridge 7C-81, Hackstaff Road

Stream Channel:	In the vicinity of the preferred bridge, Long Valley Creek has a well defined, flat bottom, slightly incised flood channel with an average slope of approximately 0.3-percent (decimal 0.003) and bed materials consisting of fine sand and silt. Photos 5 and 6 (page 13) show Long Valley Creek looking downstream and upstream from the existing bridge.
Stream Banks:	The banks of Long Valley Creek are very steep to near vertical and consist of cohesive silty loam with a light grass cover on shallower slopes.
Existing Bridge:	The existing bridge is aligned near perpendicular to the direction of flood flow in Long Valley Creek.
Site Topography:	Figure 4, page 17

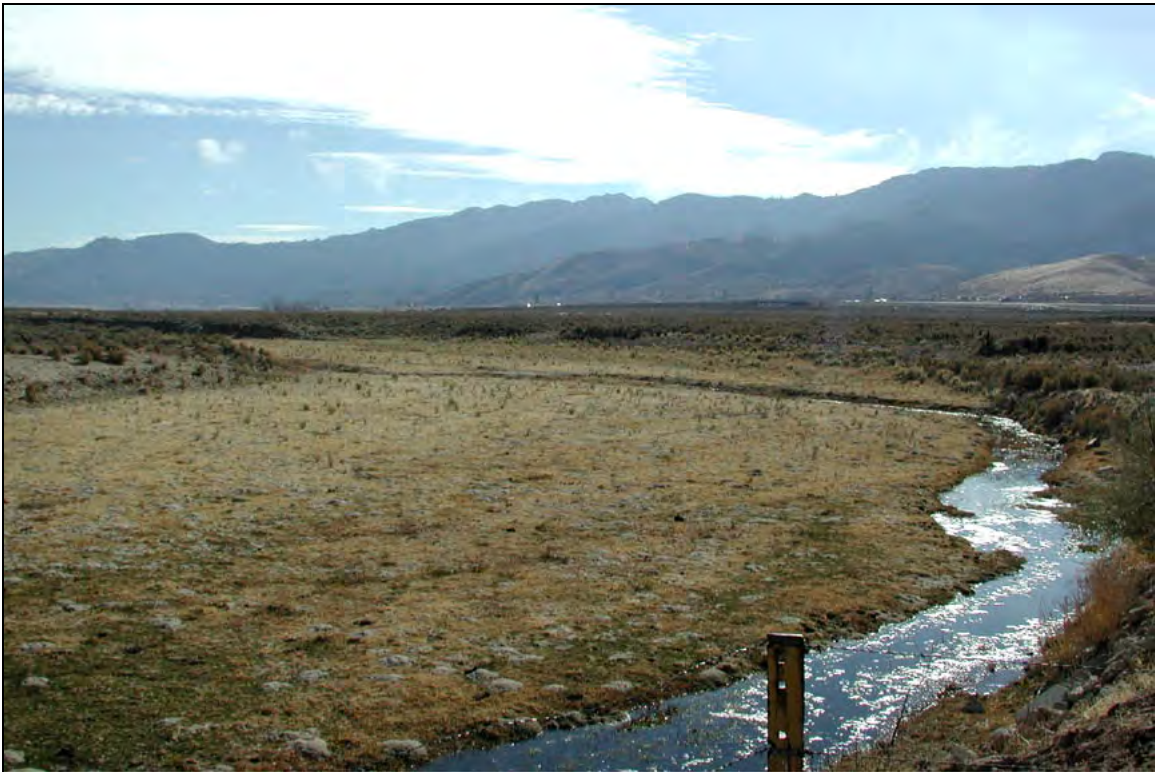
Photo 6: Looking upstream (south) at Long Valley Creek  
from Bridge 7C-81, Hackstaff Road

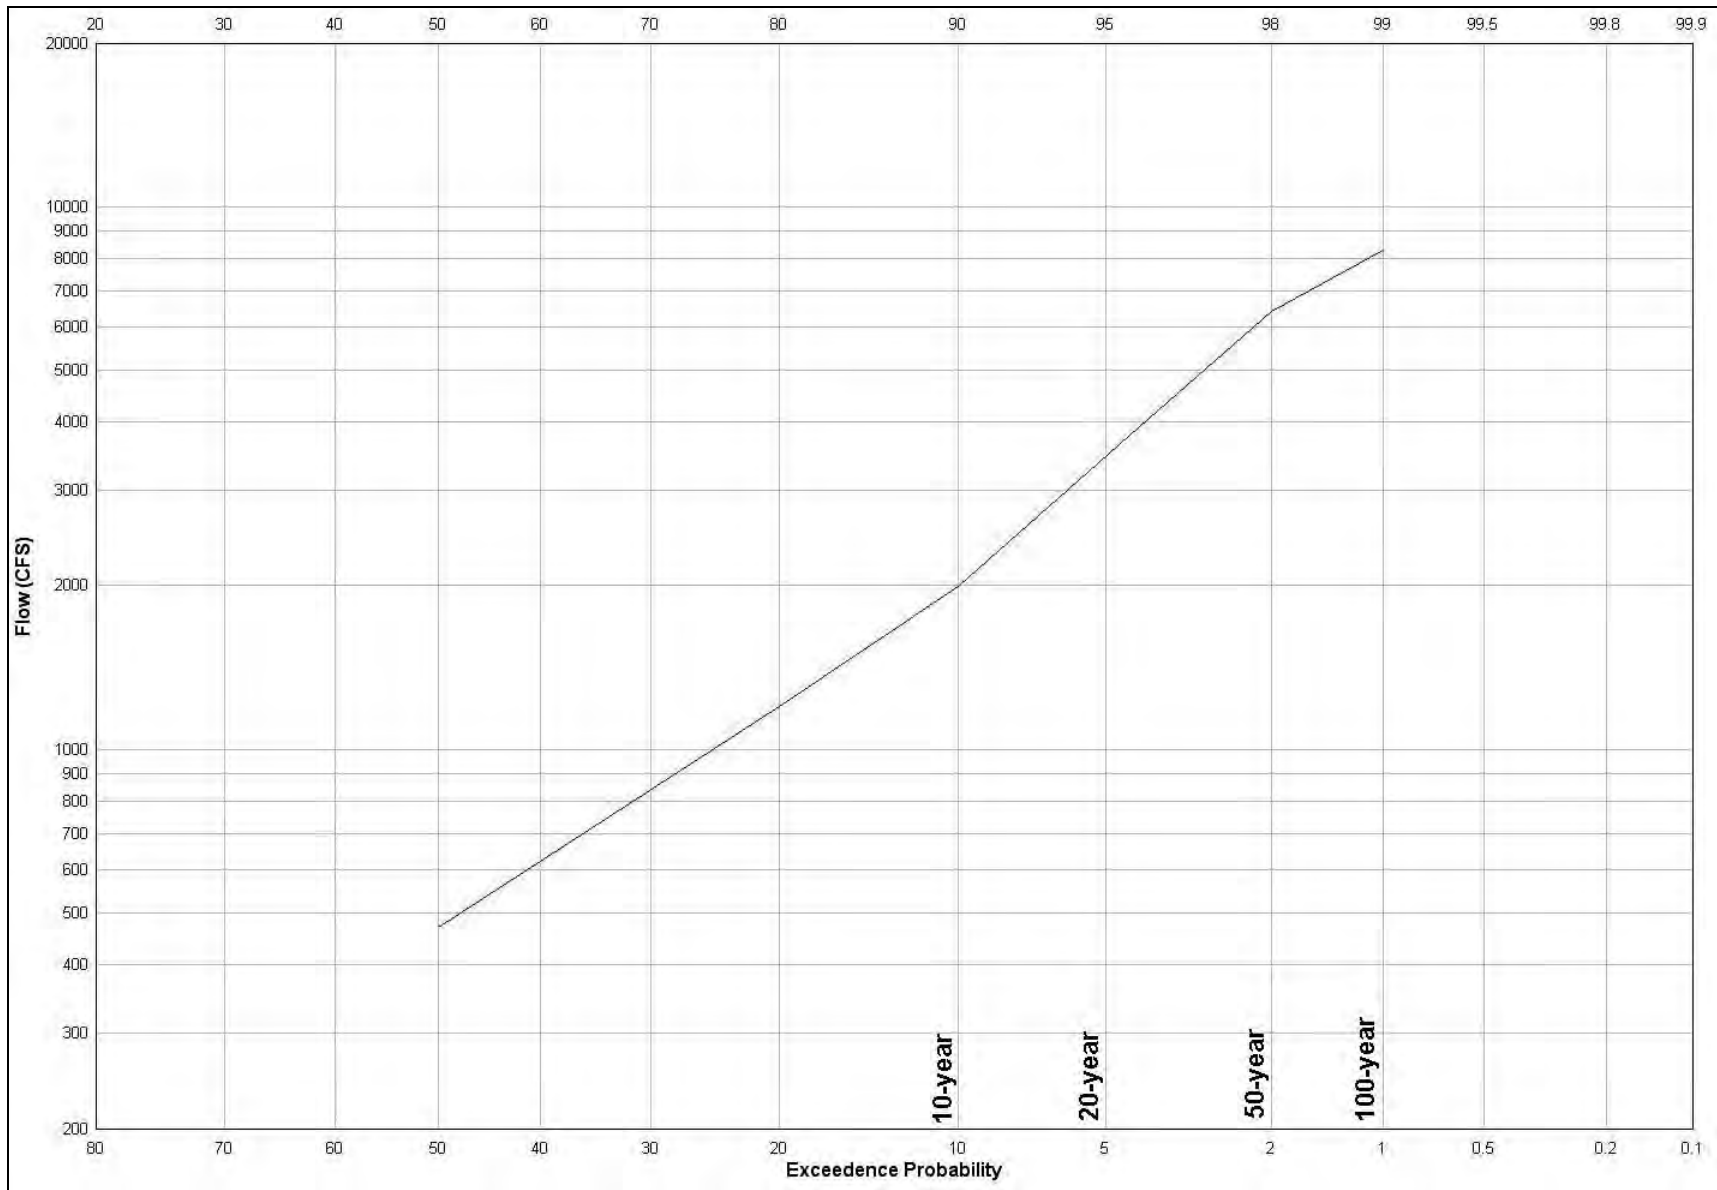
Figure 5: Flood Frequency Curve, Long Valley Creek at Hackstaff Road

Selected flood frequency relationship – The flood frequency relationships estimated from Steamboat Creek adjusted using Nevada Region 6 Exponents has been selected as most appropriate for design of the replacement bridge. This estimate has been selected because of the long length of peak flow records at the Steamboat Creek streamgage and because of corroboration by other methods. Other estimates were not selected because of the more regional nature of the methods. The selected flood frequency relationship is shown in Figure 5 (page 18).

**Flood Peak Flows:** Candidate flood frequency relationship – All candidate flood frequency curves derived from translation analysis for the proposed project site are plotted and shown in Appendix A. Estimated 50- and 100-year flood peak flows from all methods investigated are summarized in Tables 2 and 3.

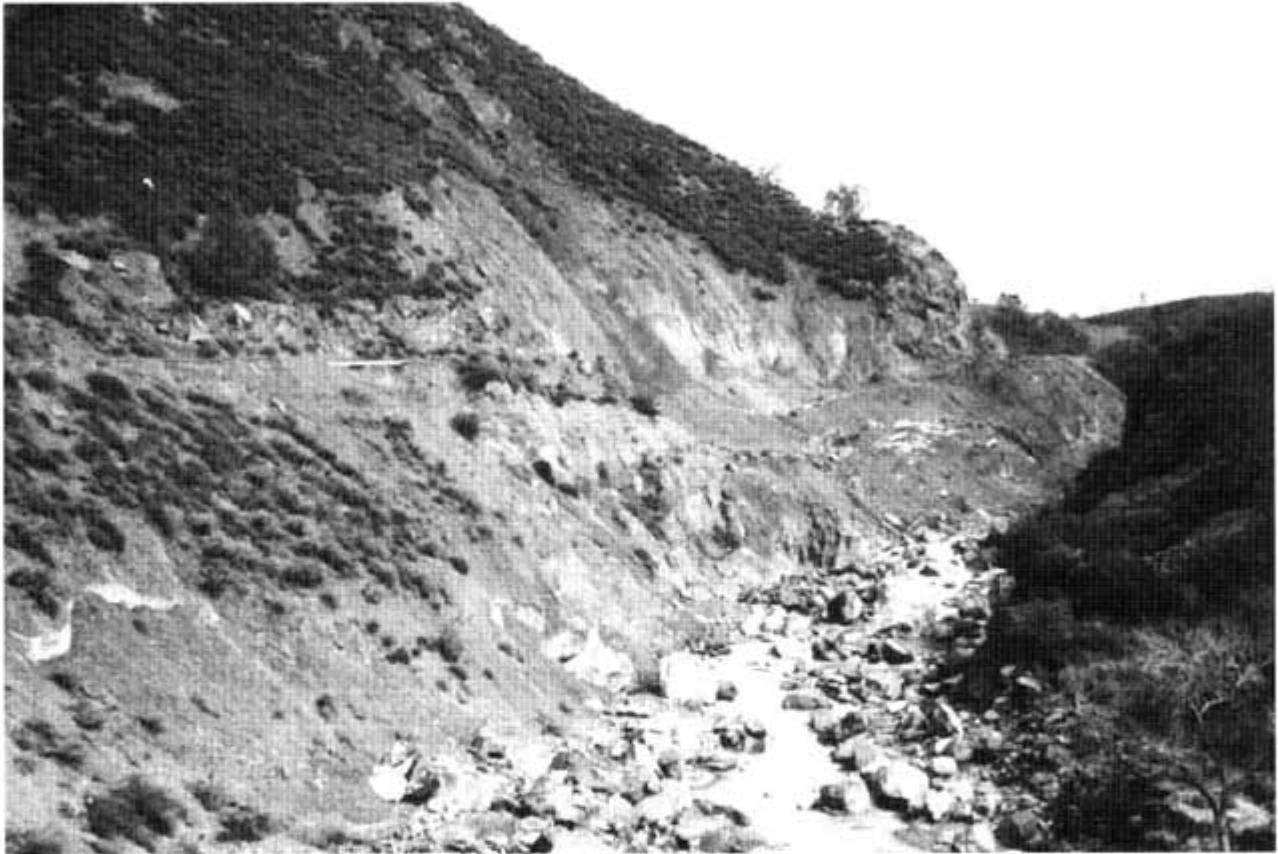
*Figure 1. Jones Slide, February 1998. Larger boulders in Tres Pinos Creek are over 20-feet.*

During the modest storm of February 3, 1998, a known landslide upstream of several bridges slipped and deposited a substantial volume of rock in Tres Pinos Creek. The weather in 1998 was influenced by a strong El Nino pattern. As such, coastal regions in California received much more precipitation than normal and ground saturation levels were much greater than normal. During a frontal storm event in the first week of February, a modest storm cell tracked from the Big Sur area, through Pinnacles State Park, and through the Tres Pinos Creek basin. Based on regional flood damage the magnitude of the Tres Pinos Creek flood flows are believed to be on the order of a 50- to 75-year flood event. Better estimates of the significance of the Tres Pinos Creek flood were hampered by the loss of streamgages, the lack of precipitation gages, and the high cost of rainfall-runoff modeling using NEX-RAD data. The transient aggradation process resulting from the landslide and flood event damaged the recently constructed Appel Bridge located 1-mile downstream, destroyed the Callens Bridge located 6-miles downstream and left the Graves Bridge, 8-miles downstream, high and dry. Two additional bridges located in the reach suffered minor damage. A bridge damage survey report was prepared to identify and document the nature and causes of damage at the bridges. The "Jones Slide", as it became known, is shown in Figure 1.

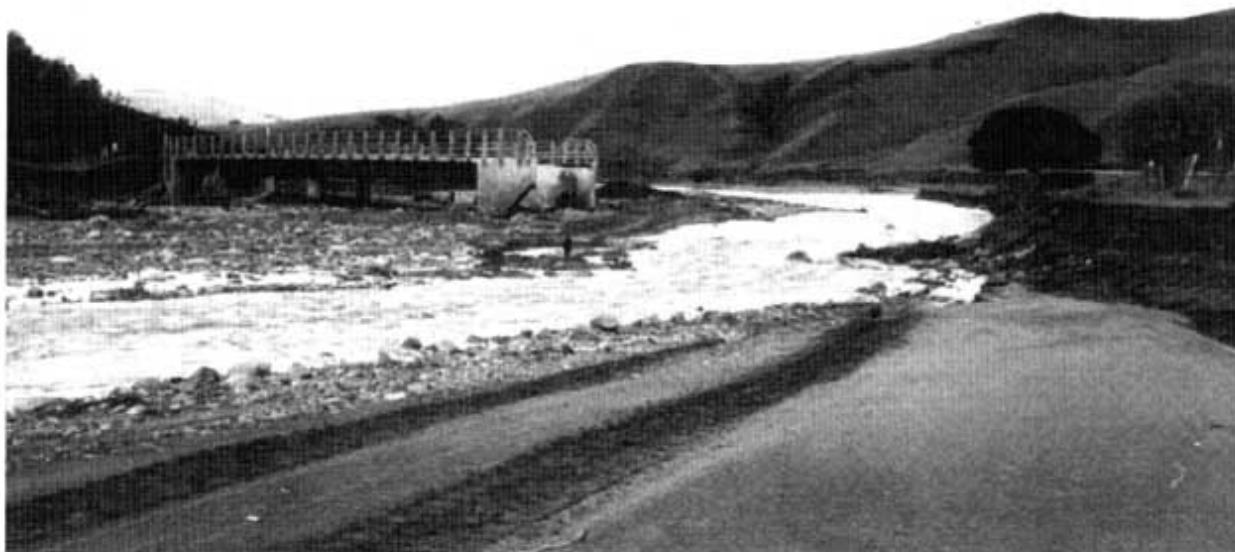
Figure 2. *Appel Bridge after Jones Slide and flood of February 1998.*

Of particular interest were the damages to the Appel Bridge located closest to the landslide. The Appel bridge was built in 1995 after the previous structure had been seriously damaged by floods earlier that year. Recognizing risks associated with channel instability, deep, large diameter shaft foundations were selected for the replacement bridge piers and abutments. Because the bridge was designed to meet currently recommended minimum bridge design standards, damage at this bridge was unexpected. The damage consisted of the loss of both bridge approaches (Figure 2). The bridge structure itself did not sustain damage. The reformed stream channel was located off the end of the bridge. The former location of the stream channel had been filled with approximately 3 feet of new deposits. High water marks indicated that the bridge and road had not been overtopped.

An evaluation of conditions observed at the site confirmed that the the stream had developed a wide, shallow geometry and had eroded through Panoche Road by bank erosion at high elevations (without flowing over the road or bridge). The high water marks observed at this site were approximately 2-feet above the water surface elevations estimated for the most probable 100-year flood at the time the bridge was designed. Bank protection that was designed to minimize the risk of damage at the abutments during floods up to the most probable 100-year flood had been overtopped and failed due to the loss of supporting embankment. Progression of the Appel Bridge failure is illustrated in Figure 3. If the bridge abutments had been founded on slab or driven pile foundations relying on bank protection to prevent structural damage, the risk of substantial bridge damage would have been very high.

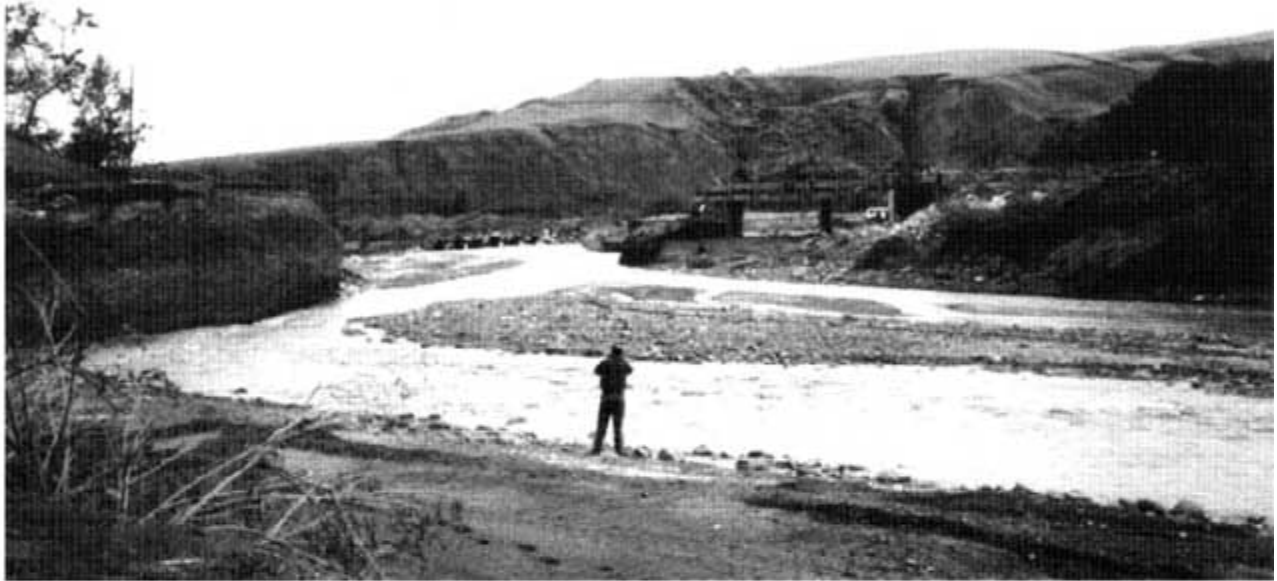
*Figure 4. Callens Bridge after Jones Slide and flood of February 1998.*

The Callens Bridge was a 95-foot long, 5-span flat slab bridge on substantially unknown foundations. The pier walls were of a design known to capture drift (floating debris). Damage to this bridge consisted of a complete loss of one abutment and three spans (Figure 4). High water marks indicated water surface elevations approximately 10-feet above the water surface elevation estimated for the most probable 100-year flood. Given the very high elevation of water marks left by the February 3, 1998 flood, bridge failure is believed to have resulted from to a combination of drift blockage and transient aggradation. Modest deposition of fine soil materials at high elevations upstream of the bridge further supports this mode of failure.

A 110-foot long clear span bridge on vertical wall abutments was selected to replace the failed bridge. Substantial bank protection was placed at and upstream of both abutments to reduce the risk of damage to abutments.

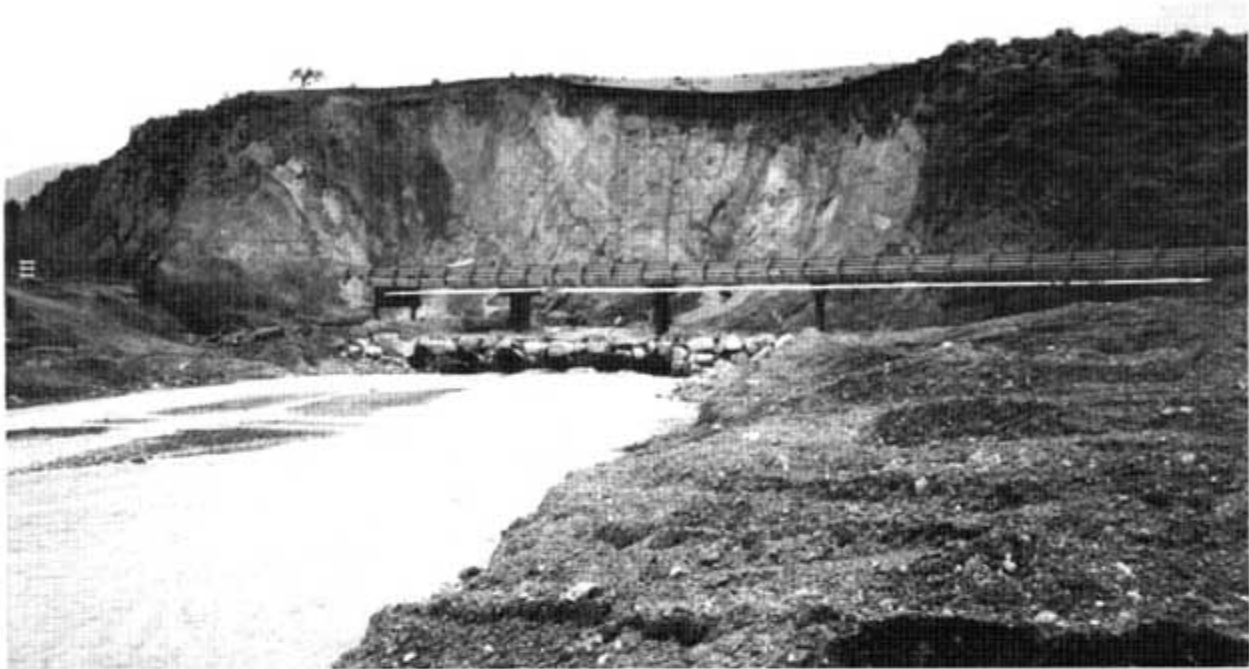
*Figure 5. Graves Bridge after Jones Slide and flood of February 1998. The stream channel had been placed back under the bridge structure but the contractor had difficulty keeping the stream channel in this location. A substantial secondary landslide is visible behind the bridge.*

As at the Appel Bridge, Tres Pinos Creek moved out from under the Graves Bridge during the transient aggradation process and reestablished outside of the bridge after the event (Figure 5). The left abutment of the bridge consisted of a short abutment wall supported on two 1-foot diameter cast-in-drilled-hole piles. After the event, more than 10 feet of the piles were exposed and unsupported. Miraculously, these piles were not damaged during the flood and the bridge structure survived. High water marks left by the February 1998 event were approximately 1 foot above the estimated high water for the most probable 100-year flood.

Recognizing that the existing bridge would remain at high risk of failure due to future pier scour, abutment scour, and bank migration, extensive evaluation was conducted before deciding to restore the existing bridge back to service. The scour risks were mitigated by placing buried cable-concrete mats in the channel and considerable rock slope protection along both banks (providing complete protection of the cross-section).

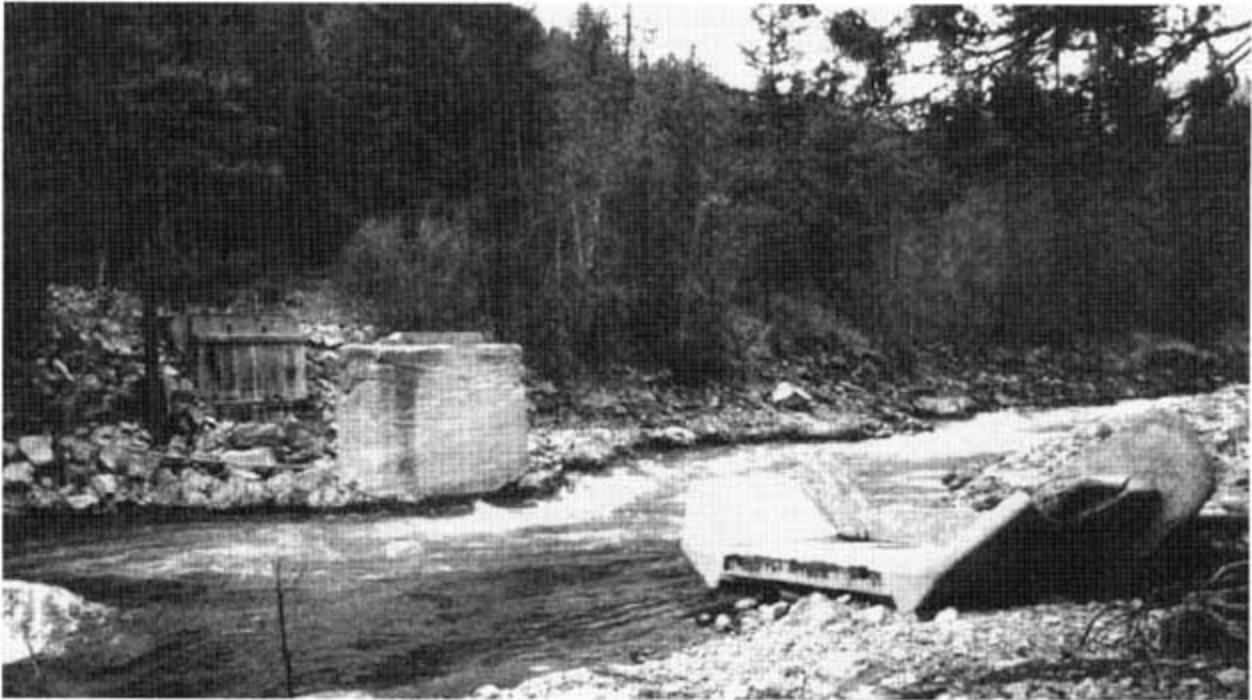
*Figure 6. Eagle Creek Loop Road over Trinity River after flood of January 1, 1997. One pier wall is submerged. The standing pier and abutment walls are on bedrock.*

During the January 1, 1997 flood, the Eagle Creek Loop Road bridge over the Trinity River was destroyed. The former bridge was a 75-foot steel truss with short approach spans. Abutments and piers consisted of reinforced concrete walls on flat slab foundations. Based on Trinity River streamgage records, the January 1, 1997 flood peak had a return period of approximately 25 years. Considerable bank erosion was present upstream of the bridge, and considerable deposition at high elevations was present downstream of the bridge. High water marks left by the January 1, 1997 flood indicated substantial blockage at the bridge sometime during the flood. It is believed that this bridge failed due to a transient aggradation process that resulted from a landslide approximately 3 miles upstream. It is not known if the bridge failed due to abutment and pier failure, due to excessive accumulation of debris on the bridge, or due to a combination of the two. Both modes of failure are associated with transient aggradation processes. The high water marks did not help identify the mode of failure because the failed structure would certainly have become a significant obstruction to flood flows. Figure 6 shows the remains of the former bridge.
